Fatal accident after rupture of expansion joint in steam pipe

Lessons learned from the occurrence on
board the Nieuw Amsterdam

The Hague, October 2025

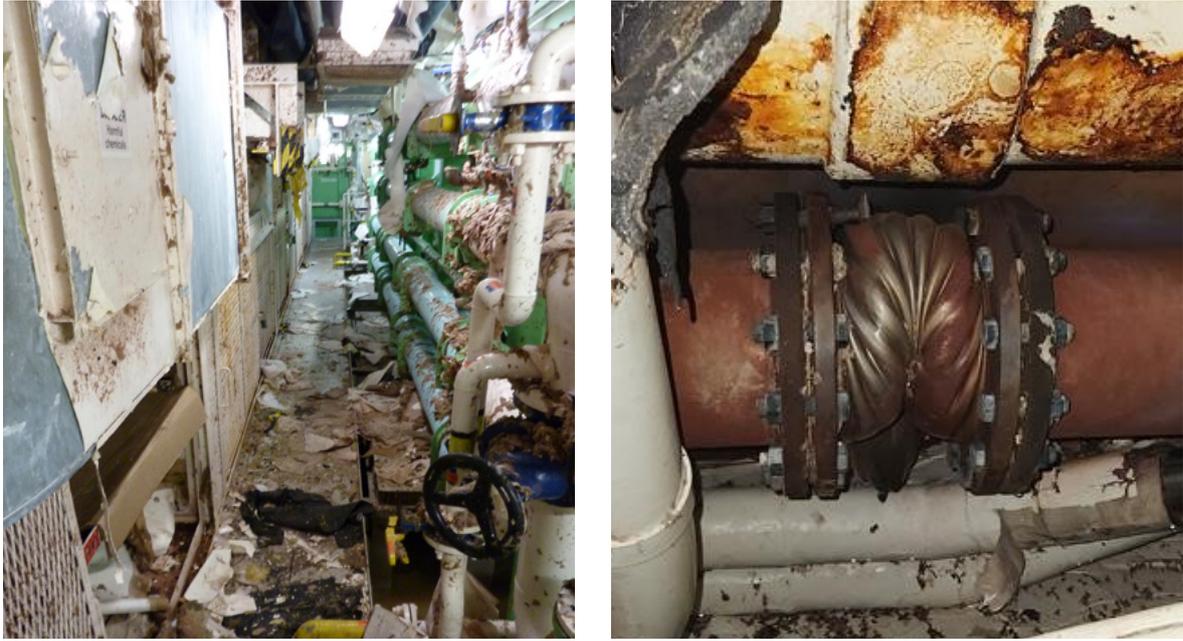
About two hours after the occurrence, it was possible to inspect the forward sewage room. On the port side, there was a great deal of damage to the insulation of the steam piping (see Figure 3, left), the paint, ventilation ducts, and other equipment. At the back of the room, on the port side, there was a ruptured expansion joint in the steam pipe that ran there (see Figure 3, right). Various plastic components had been deformed by the heat and the smoke detectors and lighting covers had melted. On the starboard side, a fibreglass tank had cracked. See Figure 4 for an overview of the room.

▲ Figure 3: Left: The situation in the forward sewage room after the occurrence (source: Dutch Safety Board). Right: The expansion joint as it was found (source: Holland America Line).

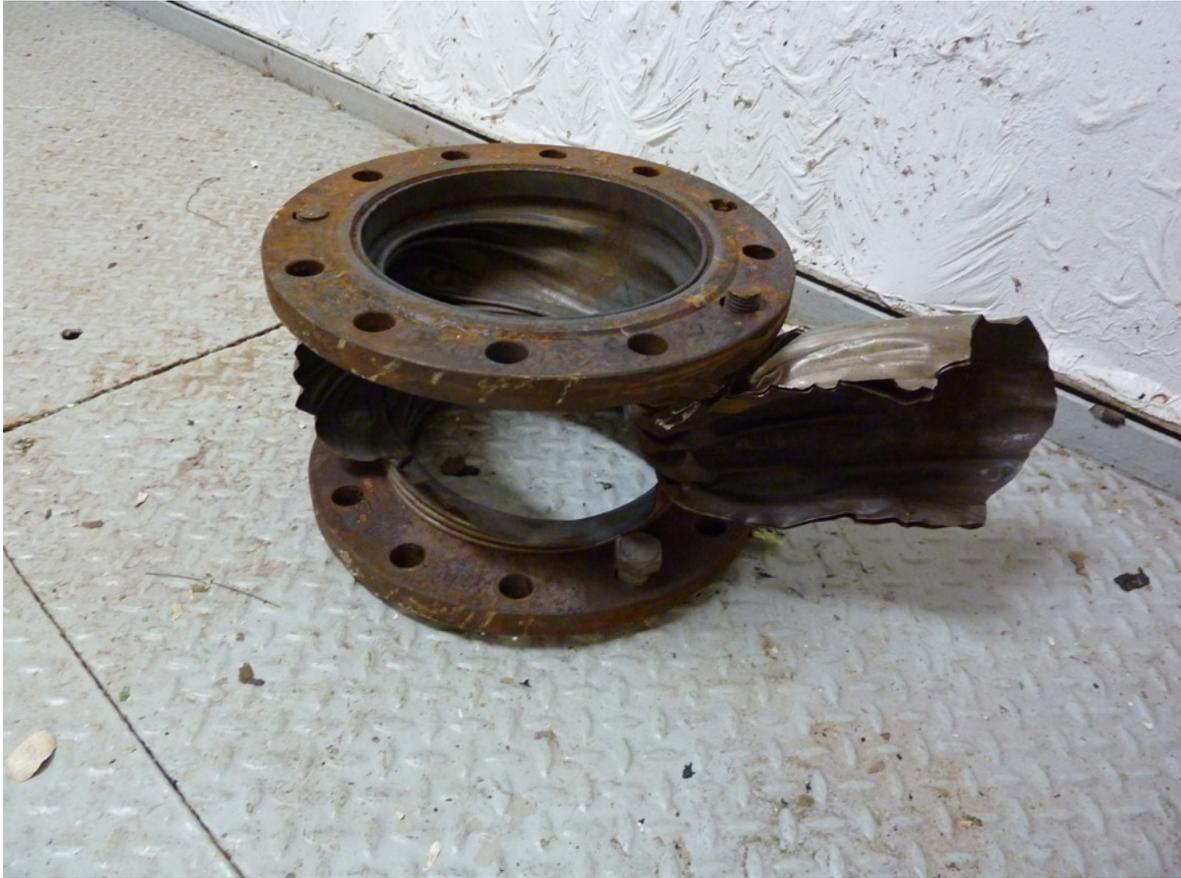
▲ Figure 10: The ruptured expansion joint after removal (source: Dutch Safety Board).

The bellows failed due to rupturing of the metal. Two ruptures ran circumferentially and were combined with one longitudinal rupture. Wherever the bellows had ruptured, it was evident that the metal had first stretched before breaking. This indicates that the metal failed due to excessive force, and not, for example, due to rust or ruptures caused by repeated stress (fatigue).

The conclusion is that the bellows failed because of overloading of the metal. It appears that the internal pressure became too high, causing the metal to rupture. The way the metal ruptured, especially longitudinally, indicates that the pressure increased suddenly or very quickly.'

1. Redesign of the steam piping in the forward sewage room of the Nieuw Amsterdam and the Eurodam. The expansion joint has been replaced by a U-bend (approved by the classification society).
2. In all the vessels in the fleet, the steam piping has been inspected to identify any previously unknown expansion joints. It has also been verified that all expansion joints have been included in the planned maintenance system.
3. An Engine Room Safety Management working group has been set up at the head office in Seattle.

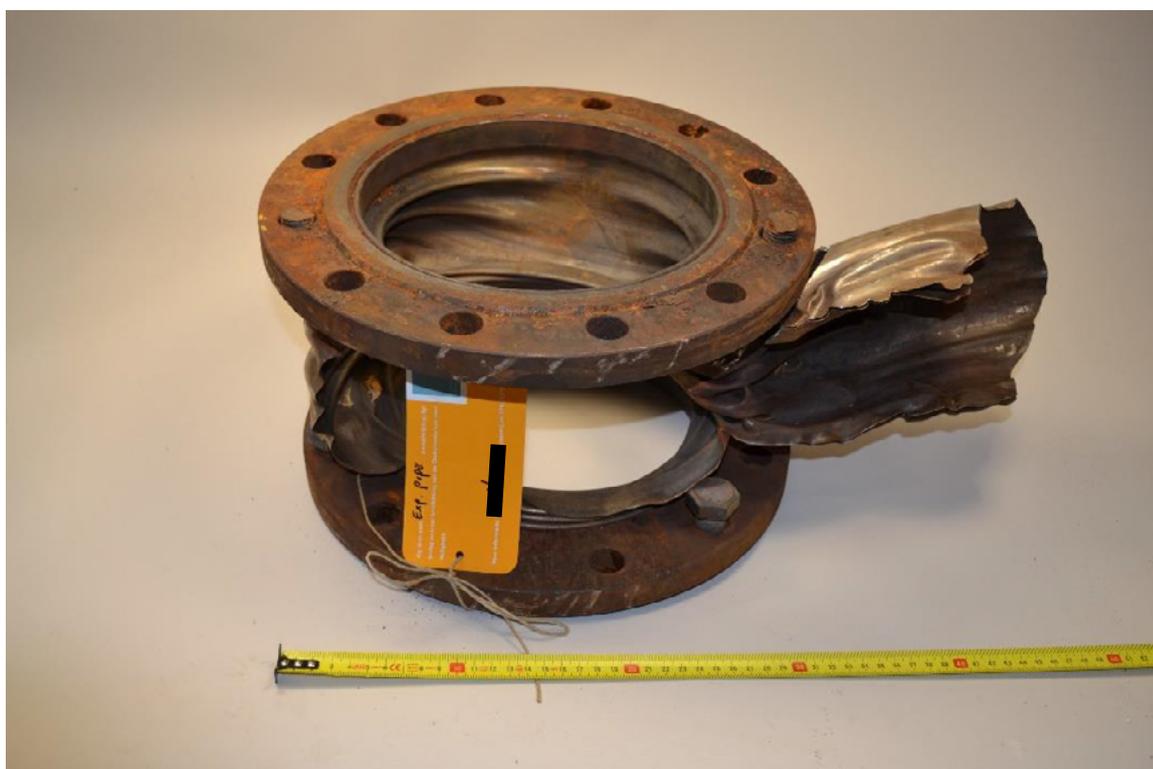
Figure 1. The failed expansion joint as received by Element Materials Technology, Amsterdam.

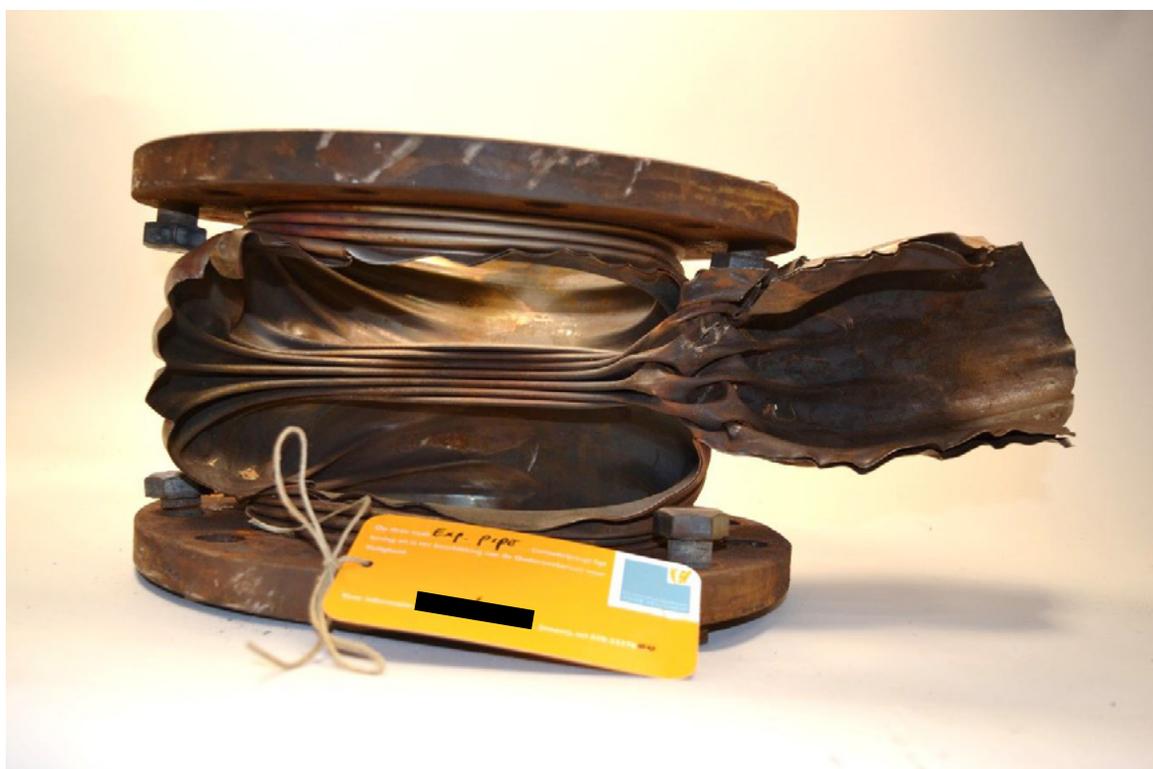
Figure 2. Overview of the fracture in the bellows with visibly expanded and compressed convolutions, the fractured double plate segment is still connected to the bellows.

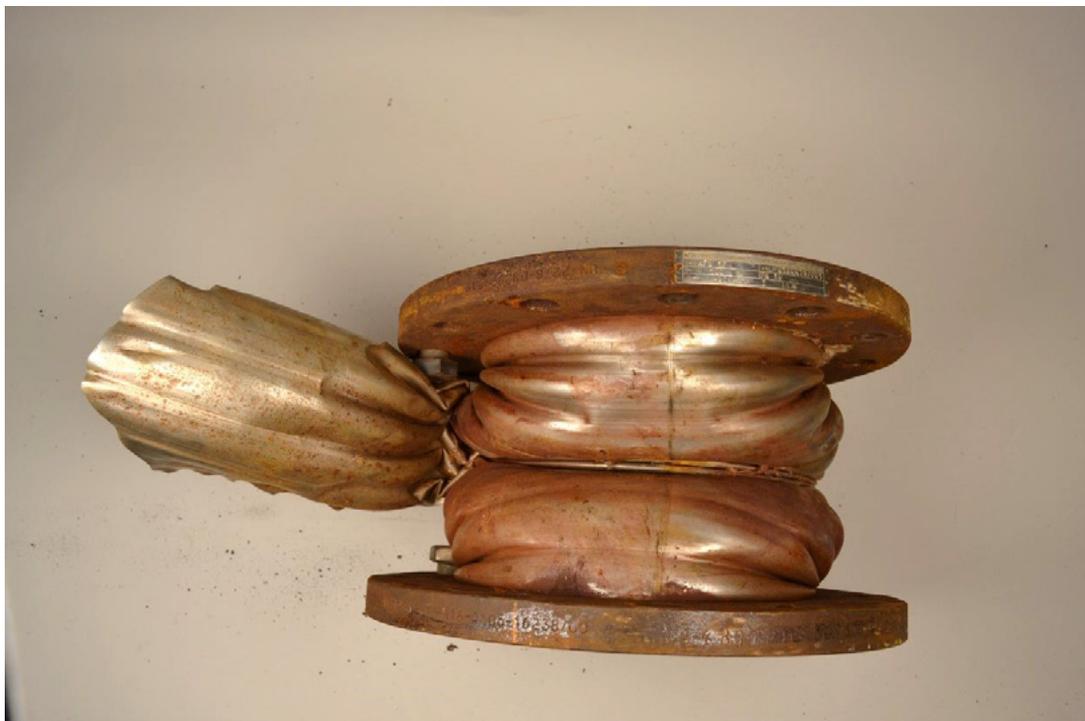
Figure 3. The unfractured side of the bellows with expanded convolutions adjacent to the central compressed convolutions. The central convolutions are obscured by the expanded convolutions on each side.

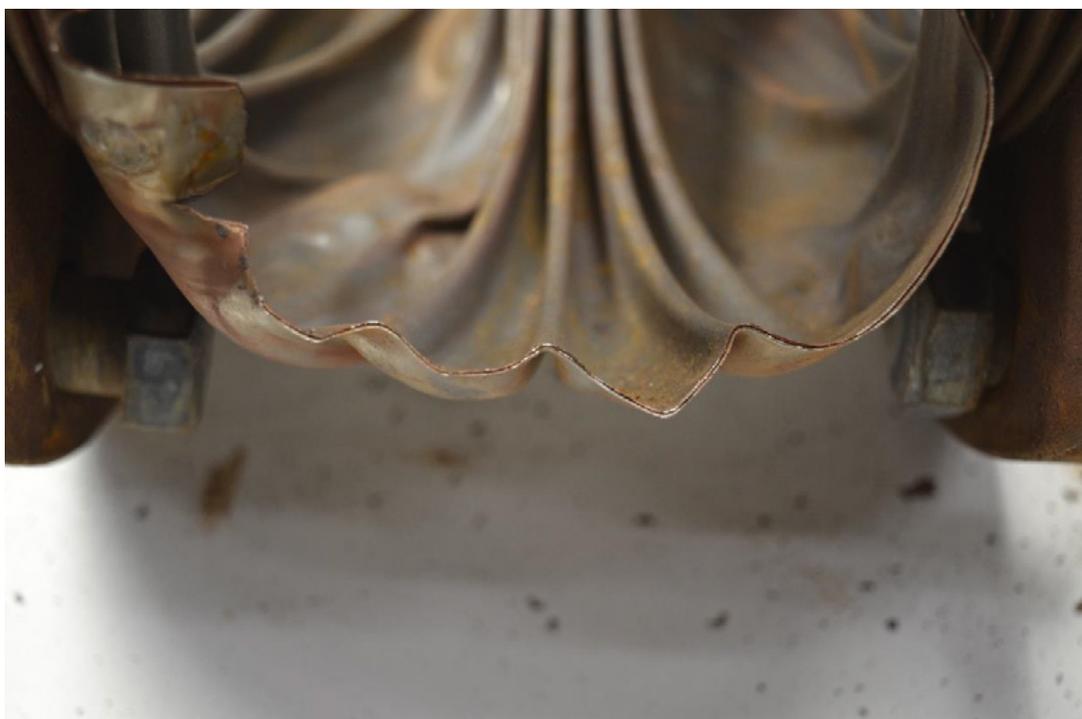
Figure 4. The fracture across the width of the bellows illustrating the exact same fracture path through both bellows plates.

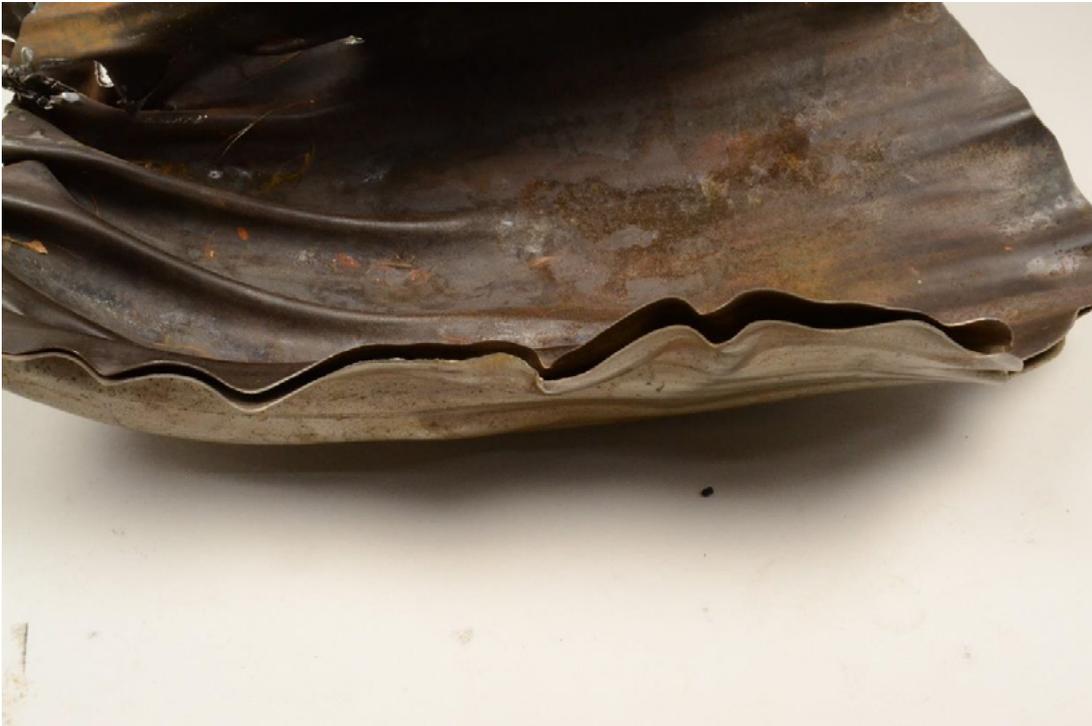
Figure 5. The fracture across along the side or circumference of the bellows illustrating the exact same fracture path through both bellows plates.

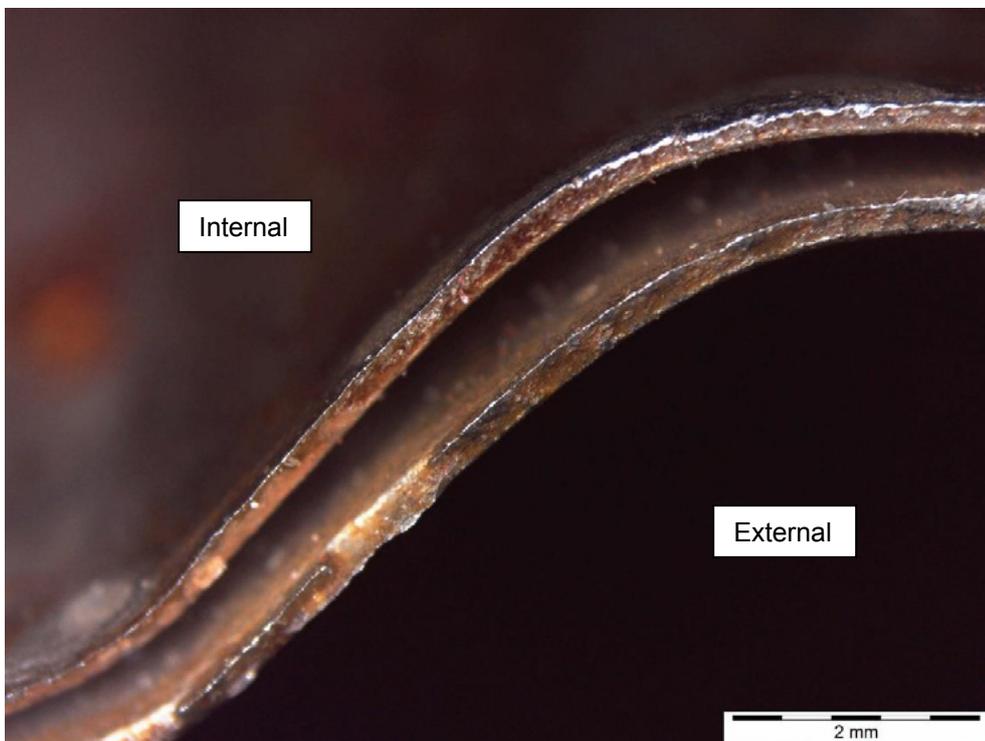
Figure 6. The fracture surfaces of the bellows plates in the fracture across the width (see figure 4 for reference). Mostly corroded fracture surface, no visible details.

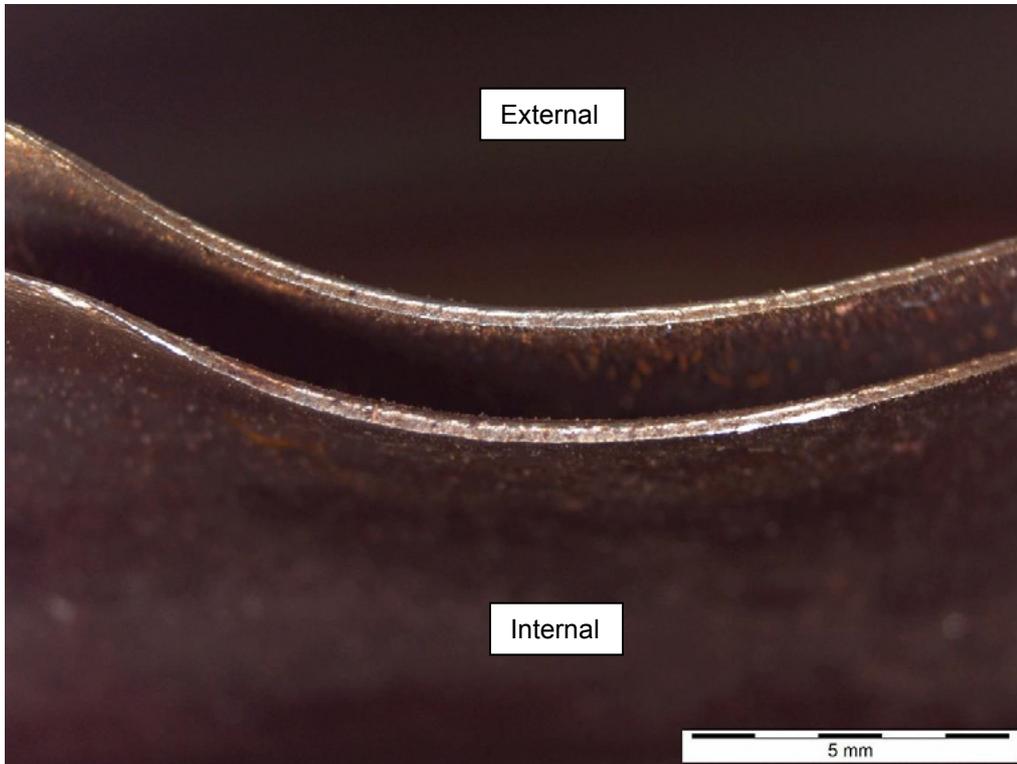
Figure 7. Detail of the fracture surfaces along the circumference, some plastic deformation appeared to be visible.

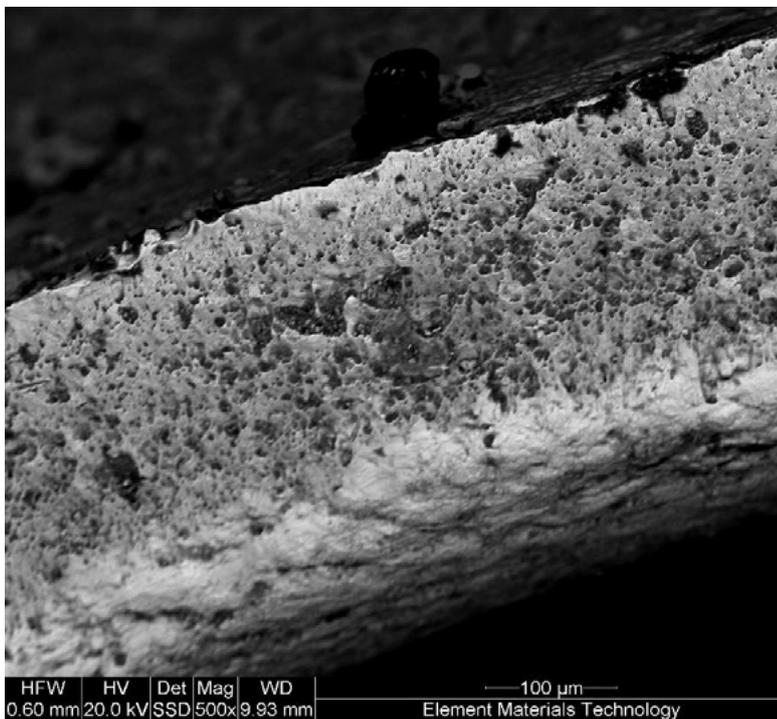
Figure 8. Typical fracture surface in bellows plate: dimple morphology and slightly corroded fracture surface.

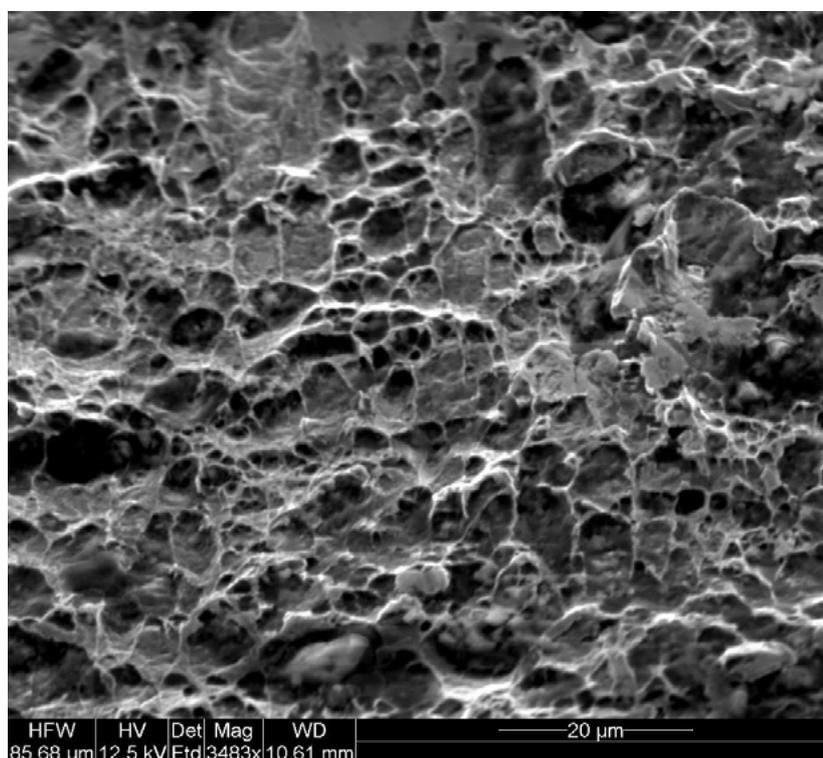
Figure 9. Internal bellow plate width section: dimple morphology indicative of ductile fracture.

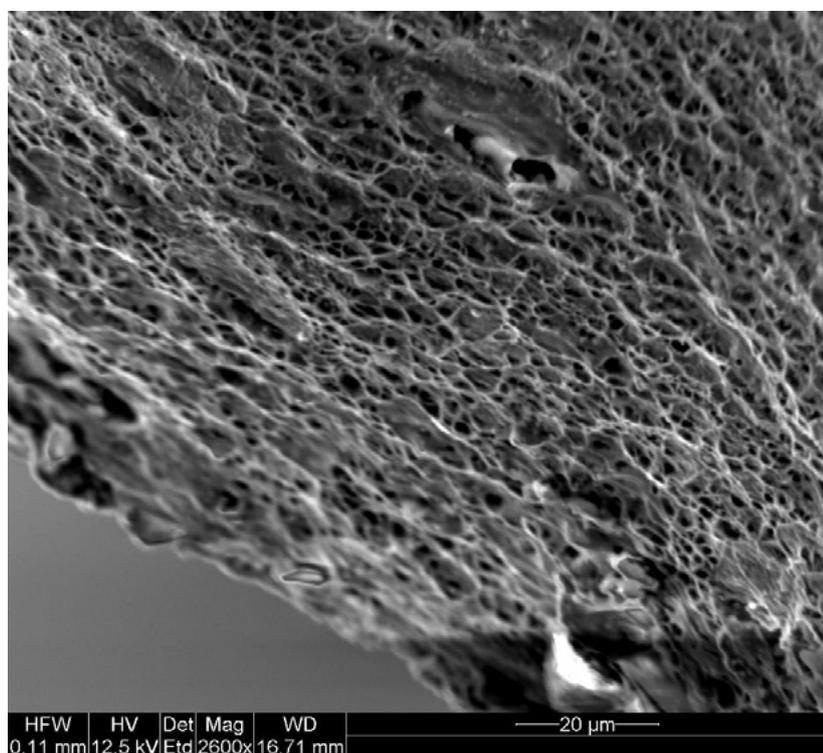
Figure 10. External bellow plate width section: dimple morphology indicative of ductile fracture

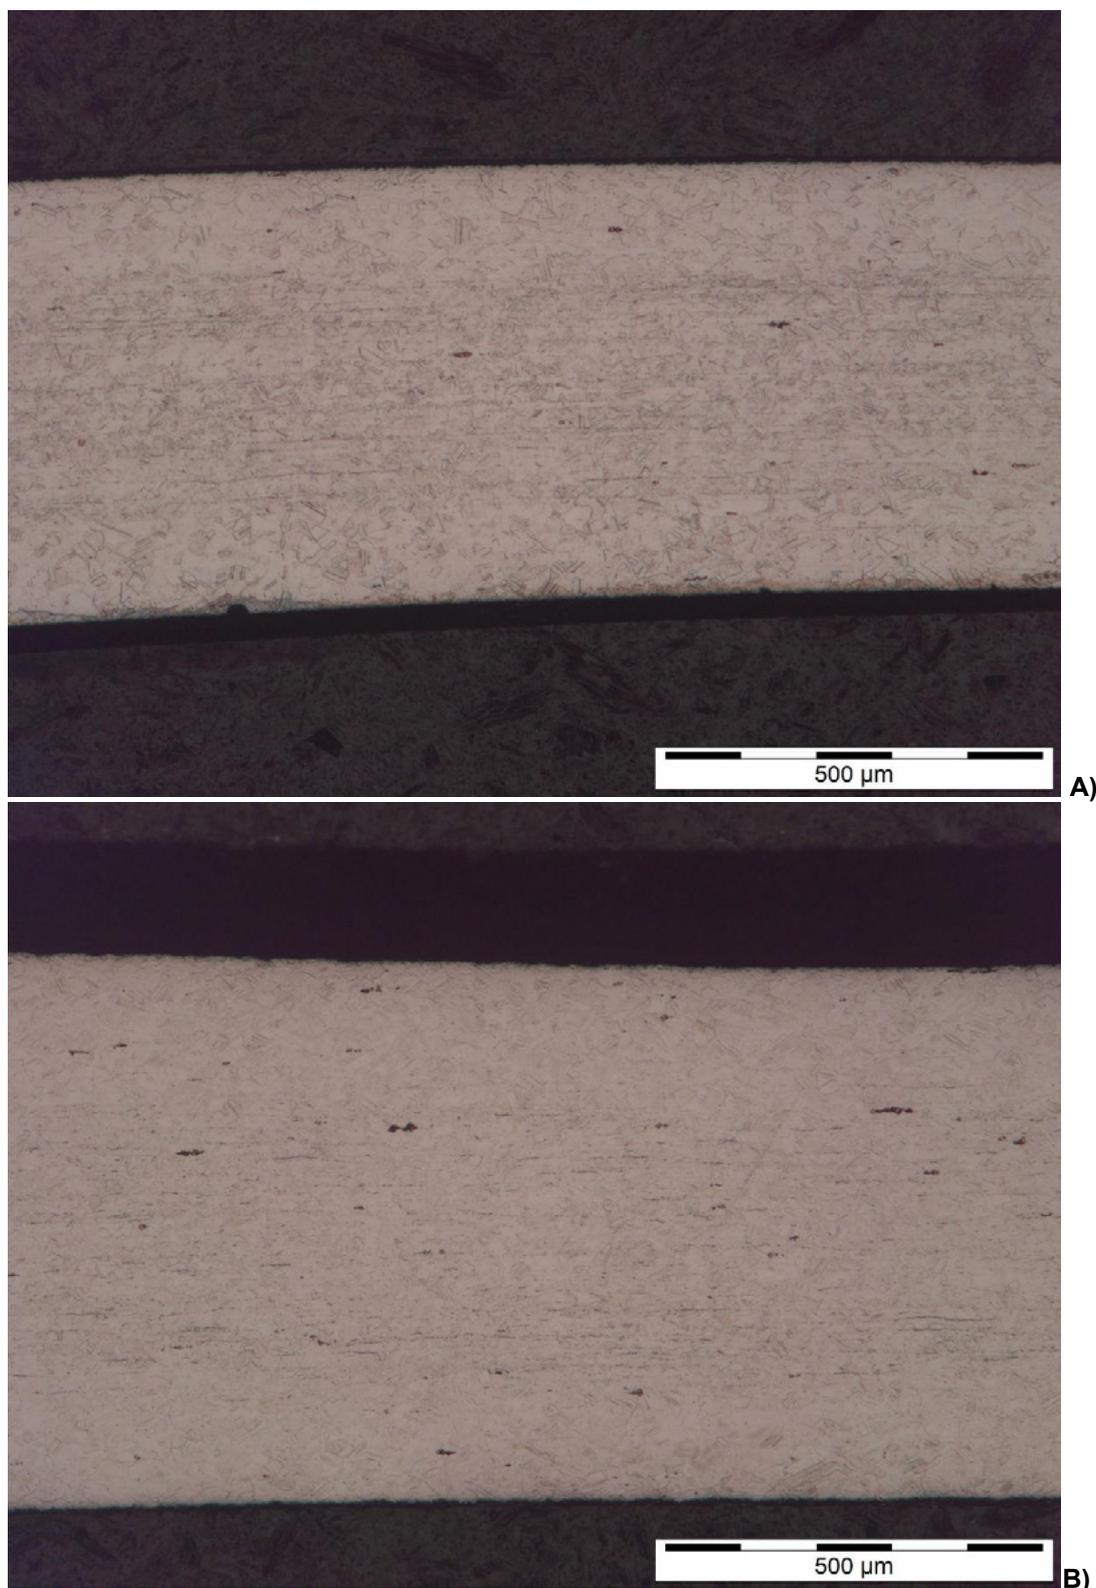
Figure 13. The general microstructures of the bellows plates, A) Internal and B) external: austenitic microstructure with deformation texture and TiN particles. (Oxalic acid etch, magn ~100x)

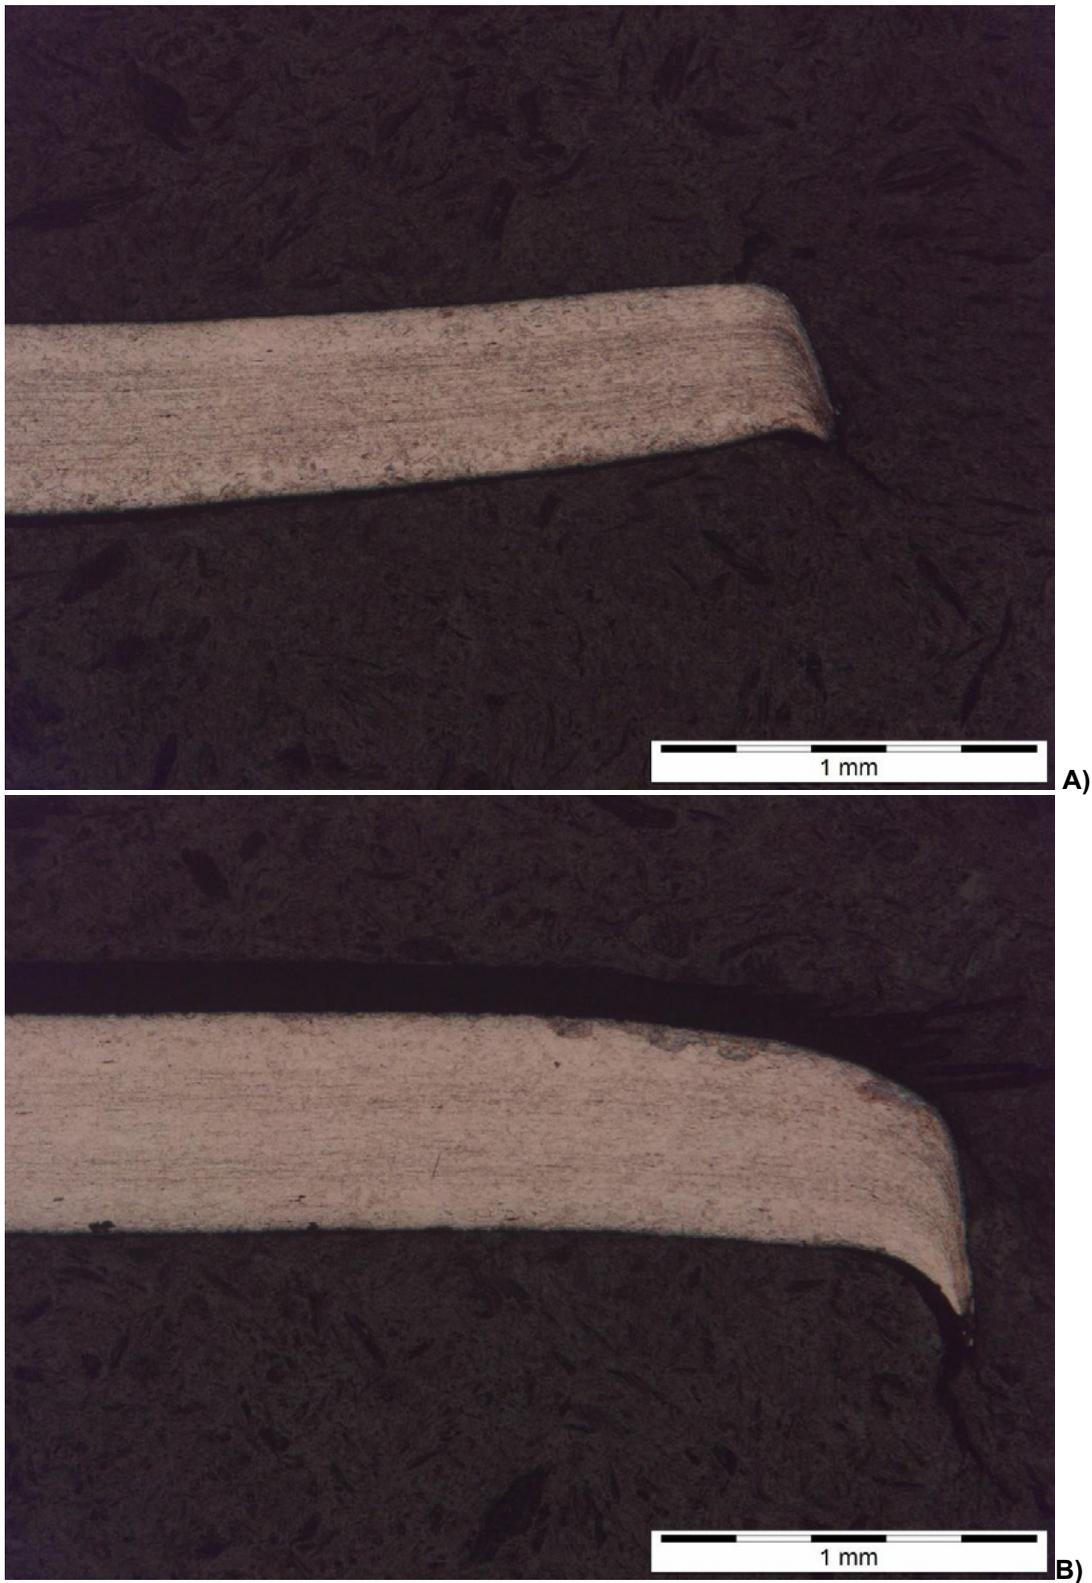
Figure 14. Fractures in cross section along the width of the bellows plates, A) Internal and B) external: plastic deformation visible at the fracture, shear type ductile fracture. (Oxalic acid etch, magn ~50x)

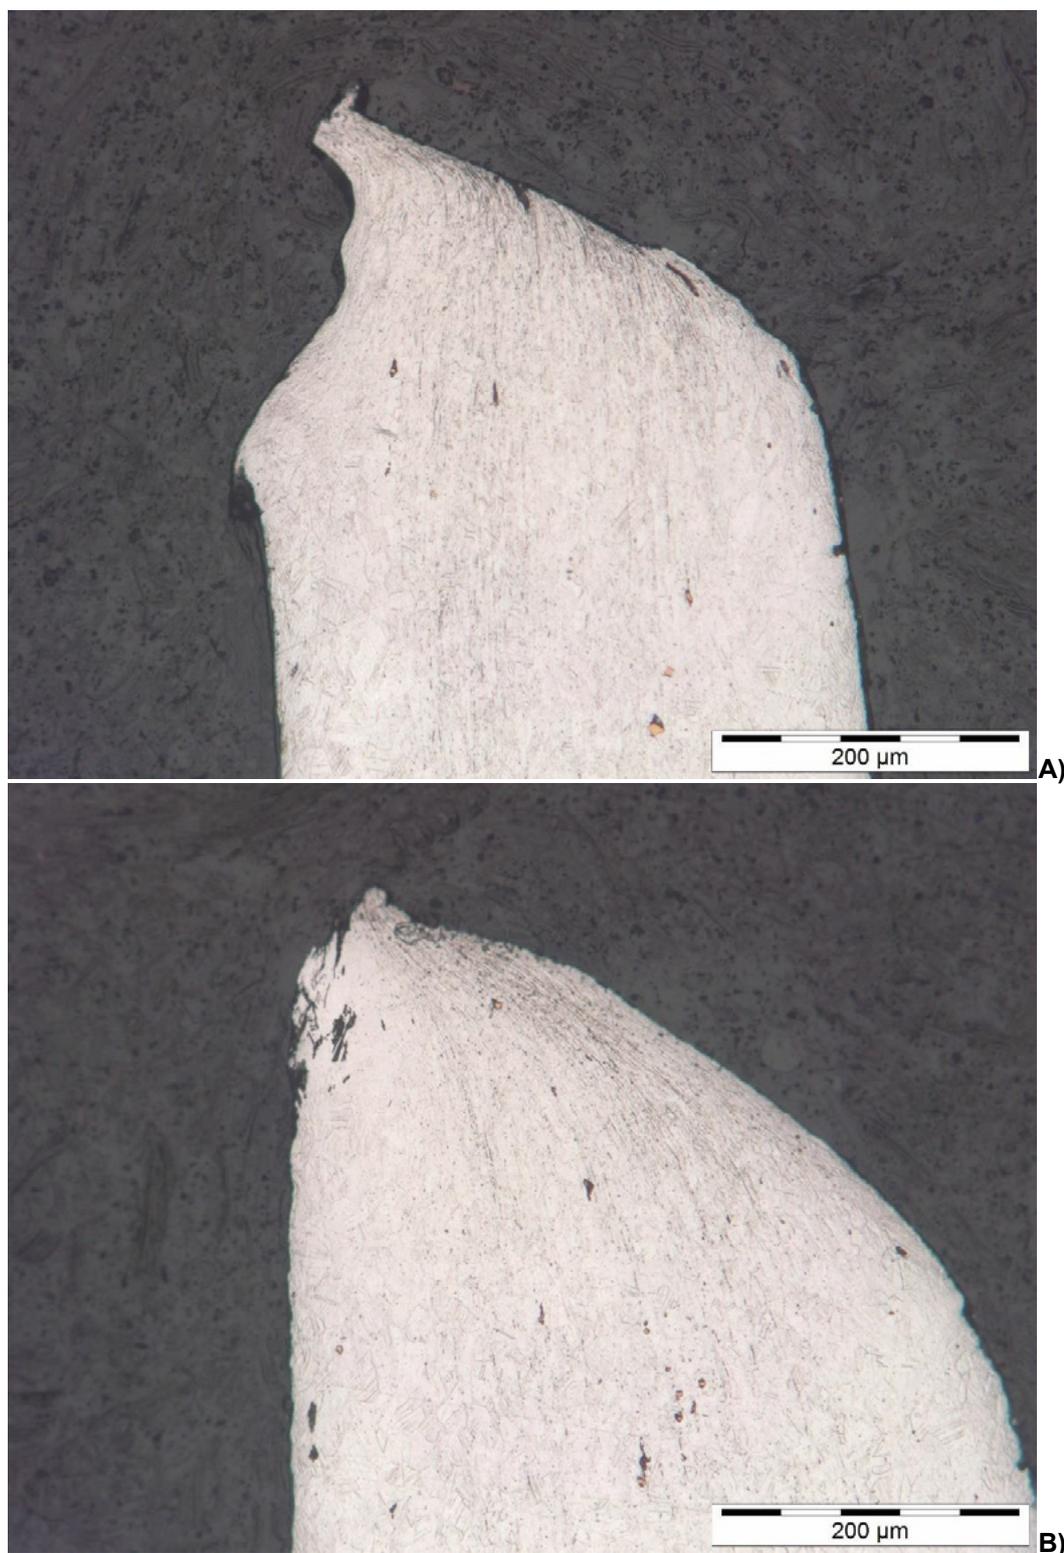
Figure 15. Fractures in cross section along the circumferential section of the bellows plates, A) Internal and B) external: plastic deformation visible at the fracture, predominantly shear fracture. (Oxalic acid etch, magn ~200x)
