Fatal accident after rupture of expansion joint in steam pipe

Lessons learned from the occurrence on
board the Nieuw Amsterdam

The Hague, October 2025

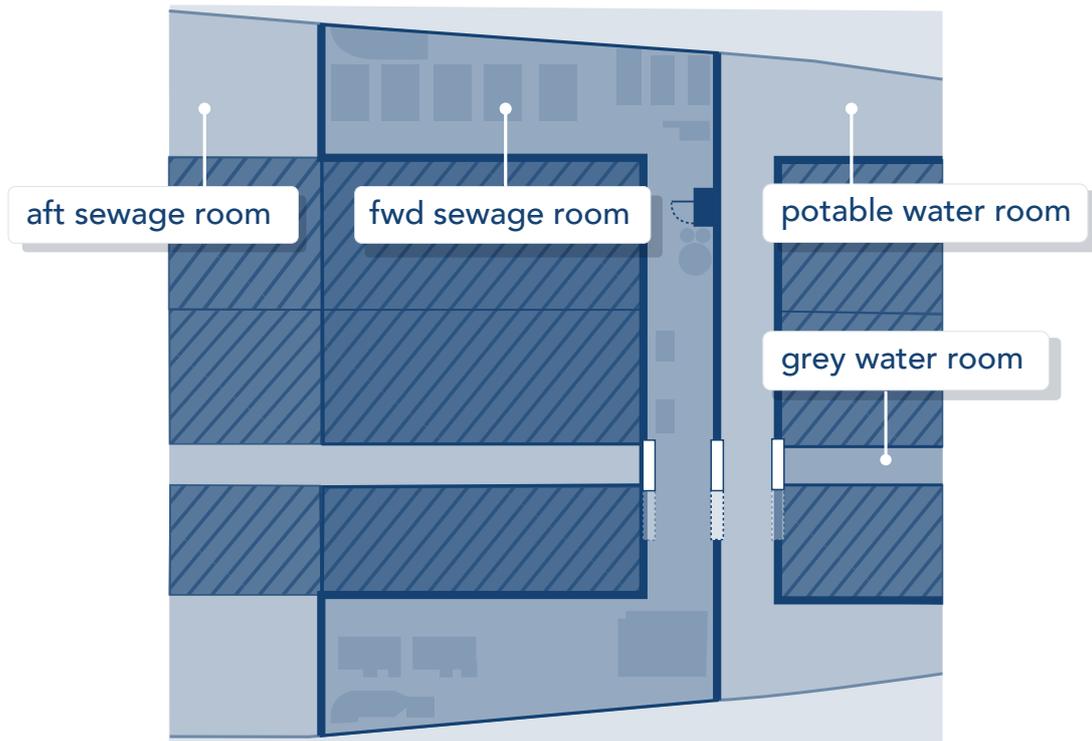
At about 08.30 hours, a third engineer officer and a motorman went to work in the forward sewage room (see Figure 1). They were carrying out routine maintenance on the sewage system⁶ on the starboard side of this room.

▲ Figure 1: Top view of the layout of the forward sewage room (source: Dutch Safety Board).

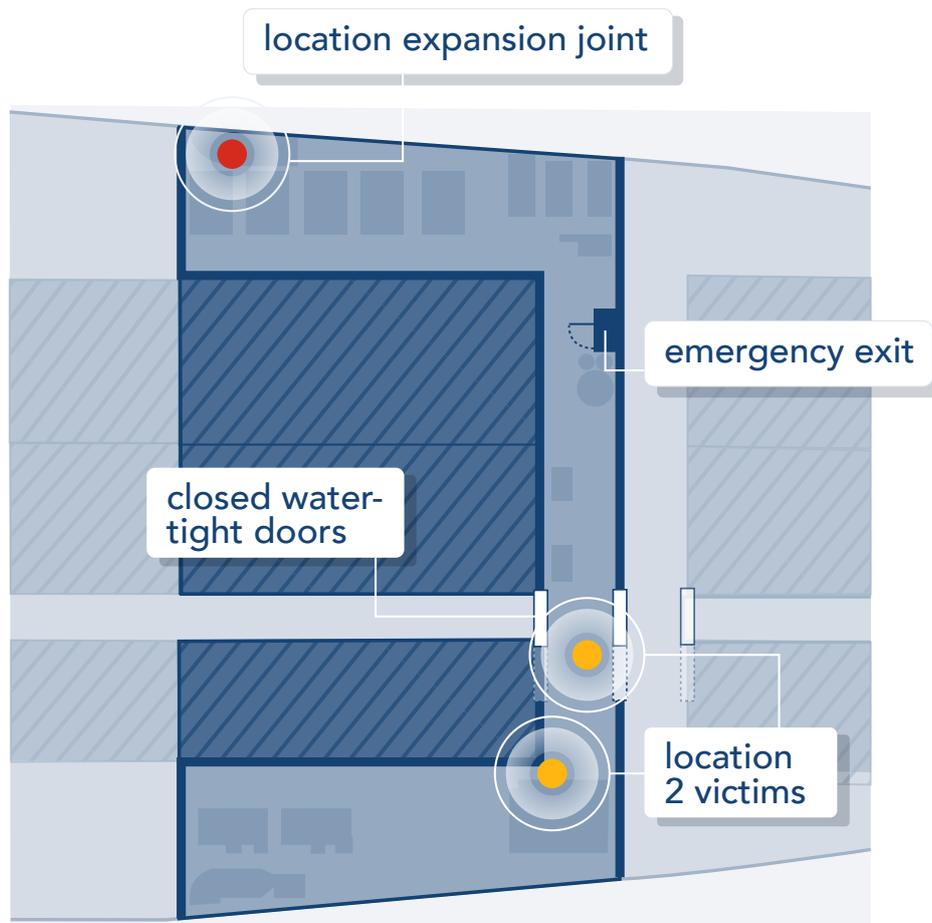
About two hours after the occurrence, it was possible to inspect the forward sewage room. On the port side, there was a great deal of damage to the insulation of the steam piping (see Figure 3, left), the paint, ventilation ducts, and other equipment. At the back of the room, on the port side, there was a ruptured expansion joint in the steam pipe that ran there (see Figure 3, right). Various plastic components had been deformed by the heat and the smoke detectors and lighting covers had melted. On the starboard side, a fibreglass tank had cracked. See Figure 4 for an overview of the room.

▲ Figure 4: Locations of the two casualties and the expansion joint (source: Dutch Safety Board).

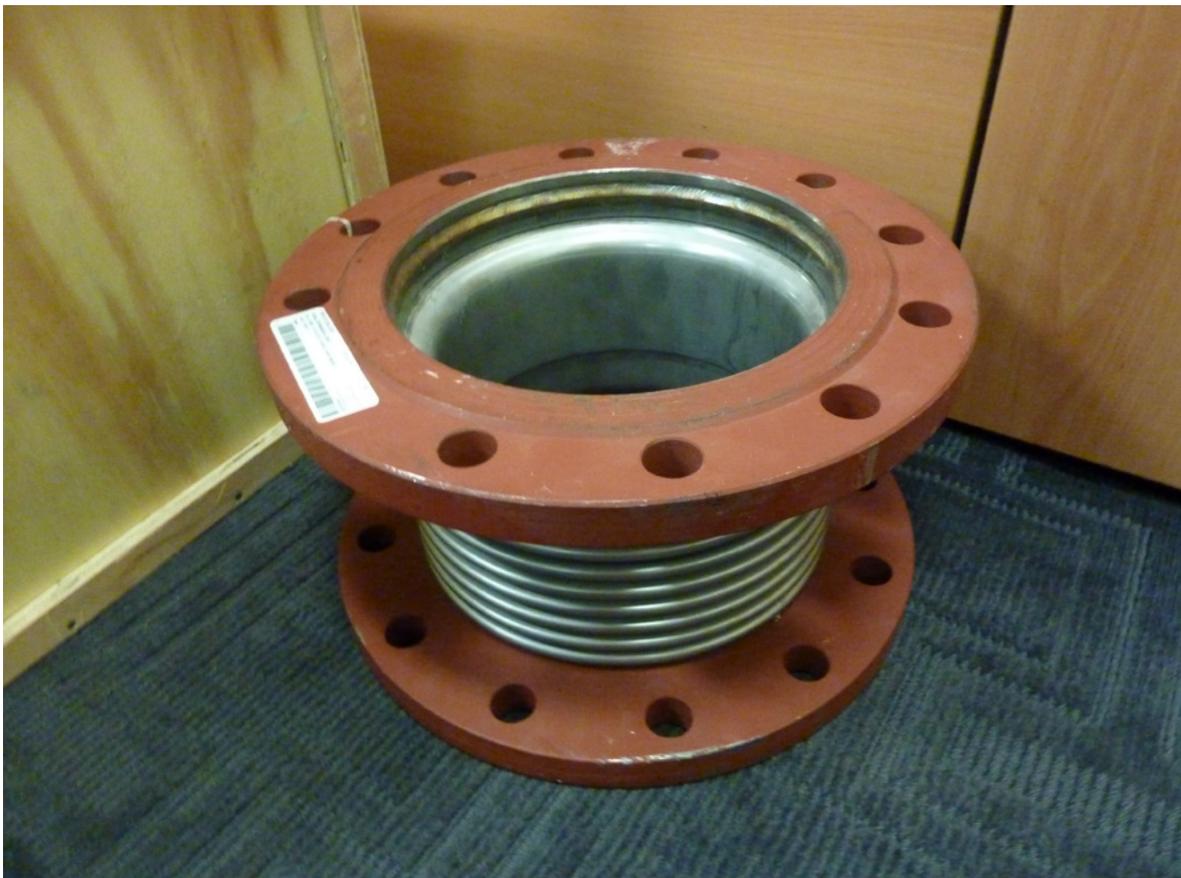
The expansion joint was made of two layers of stainless steel and designed for a maximum working pressure of 11 bar. During inspection, the expansion joint is subjected to a test pressure of 1.5 times the design pressure: 16.5 bar. For certification¹⁴, the manufacturer conducted a number of tests with the same type of expansion joint.

▲ Figure 9: New steam system expansion joint (source: Dutch Safety Board).
